DEVELOPMENT OF A METALLIC BELLOWS EXPULSION DEVICE FOR FLUORINE SERVICE

MARTIN MARIETTA CORPORATION

CONTRACT NAS3-12053

FINAL REPORT

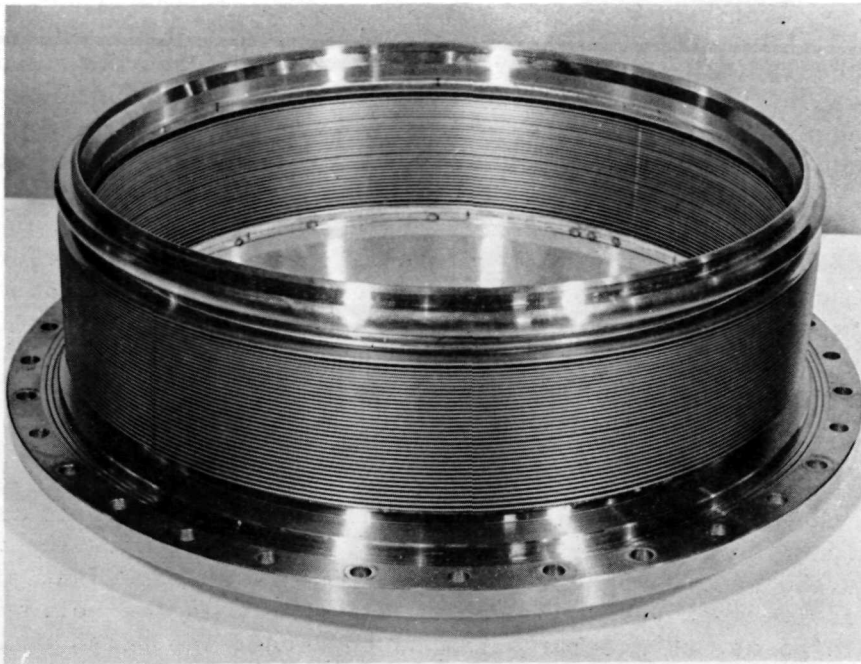
Figure 13 Bellows Subassembly as Received from DK-Aerospace

As a result of the three consecutive failures experienced by DK-Aerospace in welding the bellows to the end terminals, Martin Marietta ordered fabrication to cease until a detailed evaluation of the failures could be made and appropriate corrective actions identified. Accordingly, bellows assemblies 2 and 3 were shipped to Martin Marietta and subjected to a comprehensive failure analysis. The major results of this failure analysis were as follows:

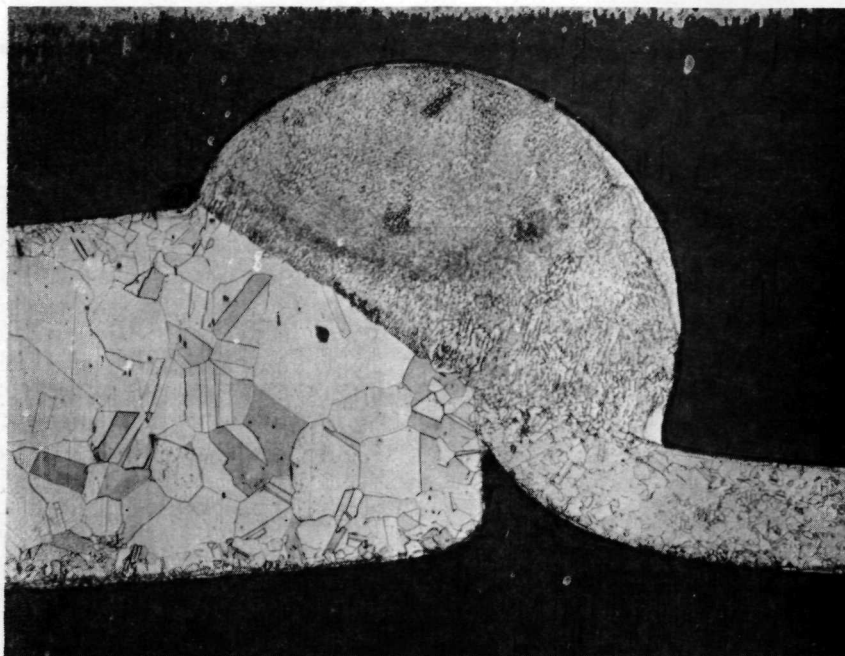
Figure 15 Region of Poor Weld Penetration,
Bellows Assembly 2

- 1) The general quality of the weld joints (determined from microscopic inspection, sectioning and metallography examination, and leak checking) showed a continuing improvement from the "practice" assembly through assembly 3, but it still left a great deal to be desired. The joints were only of mediocre quality, and were not repeatable, probably because of tooling and/or procedural deficiencies. A specific example of a region of very poor weld penetration found in assembly 2 is shown in fig. 15;

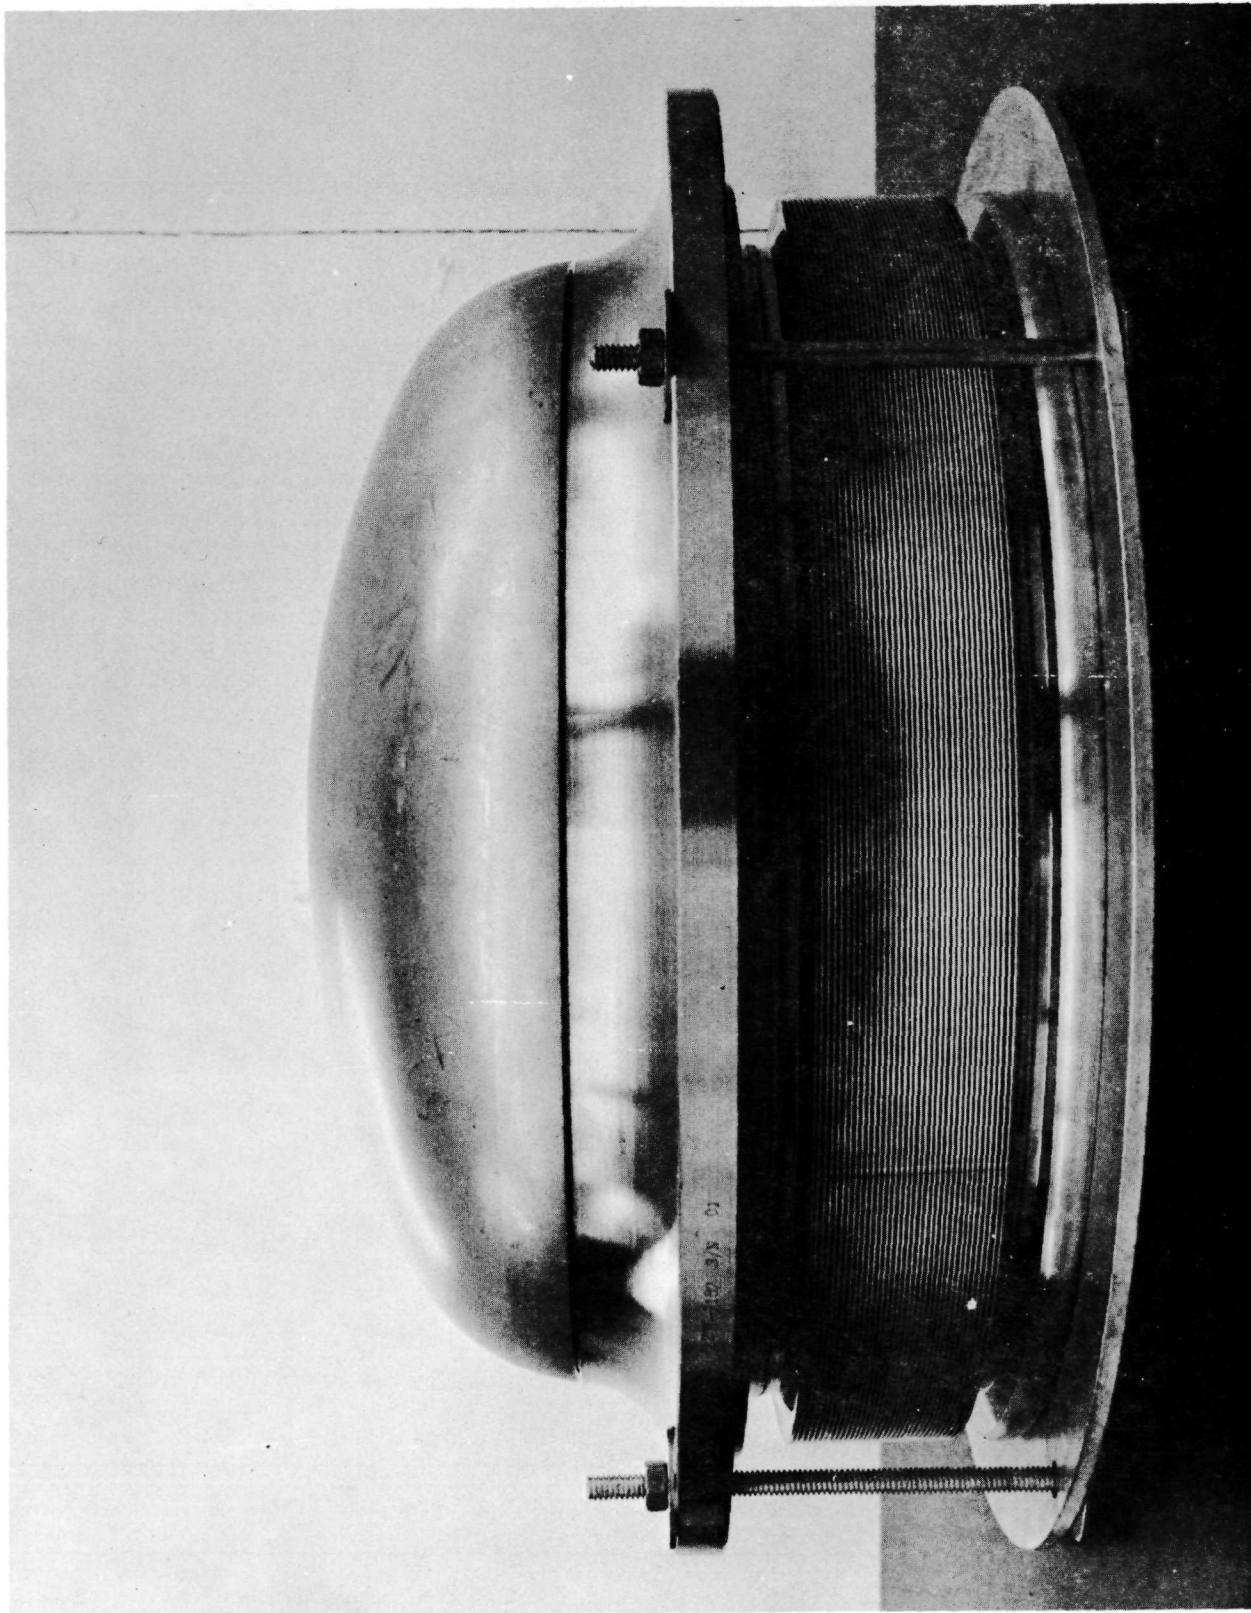
Figure 19 Dome Fit on Bellows Assembly 8

- 3) A preliminary fit of each assembly was made so that the effects of weld distortion could be quantitatively determined. First, the bellows was compressed to the proper length using the aluminum ring and bolts as shown in fig. 19. The bellows was compressed until the span of 32 convolutions, measured with dividers on the inside diameter of the bellows, was exactly 1.60 in. (406. mm), i.e., 0.050 in. (1.27 mm) per convolution. Then the bellows subassembly was set on the end dome, the movable dome inserted, and the axial distance between the end of the movable dome and the end of the guide-ring measured with the aid of a flat bar and micrometer caliper. This distance, the average of four measurements, was found to be in the range of 0.200 in. (5.08 mm) to 0.215 in. (5.46 mm) for the three assemblies (see fig. 20).

- 6) The fit of the assembly was rechecked in the same manner as before (Step 3 above). This time the axial distance between the end of the movable dome and the end of the guide ring was found to be only 0.150 in. (3.81 mm) to 0.156 in. (3.96 mm), indicating an effective axial shrinkage of nearly 1/16 in. (1.6 mm) as a result of welding.

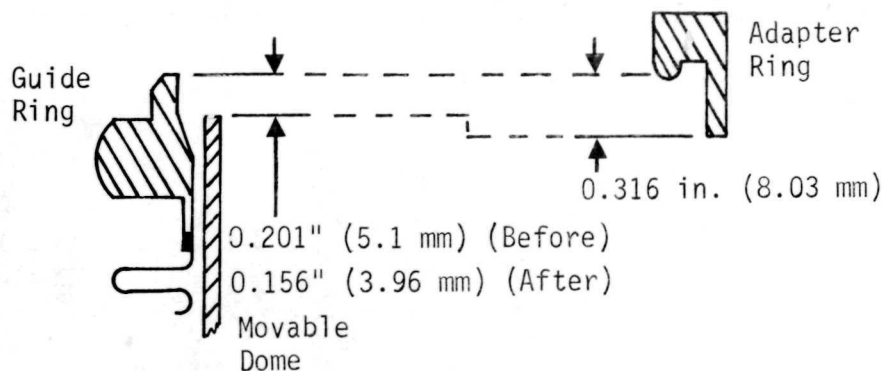
Figure 20 - Fit of Movable Dome, Assembly 6

- 7) The length of the neck on the guide ring was 0.316 in. (8.03 mm) for all the assemblies (fig. 20). The difference between this value and 0.156 in. (3.96 mm) (for assembly 6) represents the interference between the parts that is eliminated by final machining of the adapter ring. To provide a slight margin of safety (adequate length for the compressed bellows), only 0.145 in. (3.68 mm) was machined from the adapter ring instead of 0.160 in. (4.06 mm), leaving a total adapter length of 0.485 in. (12.3 mm) for assembly 6. The corresponding values for the other two assemblies were very similar.

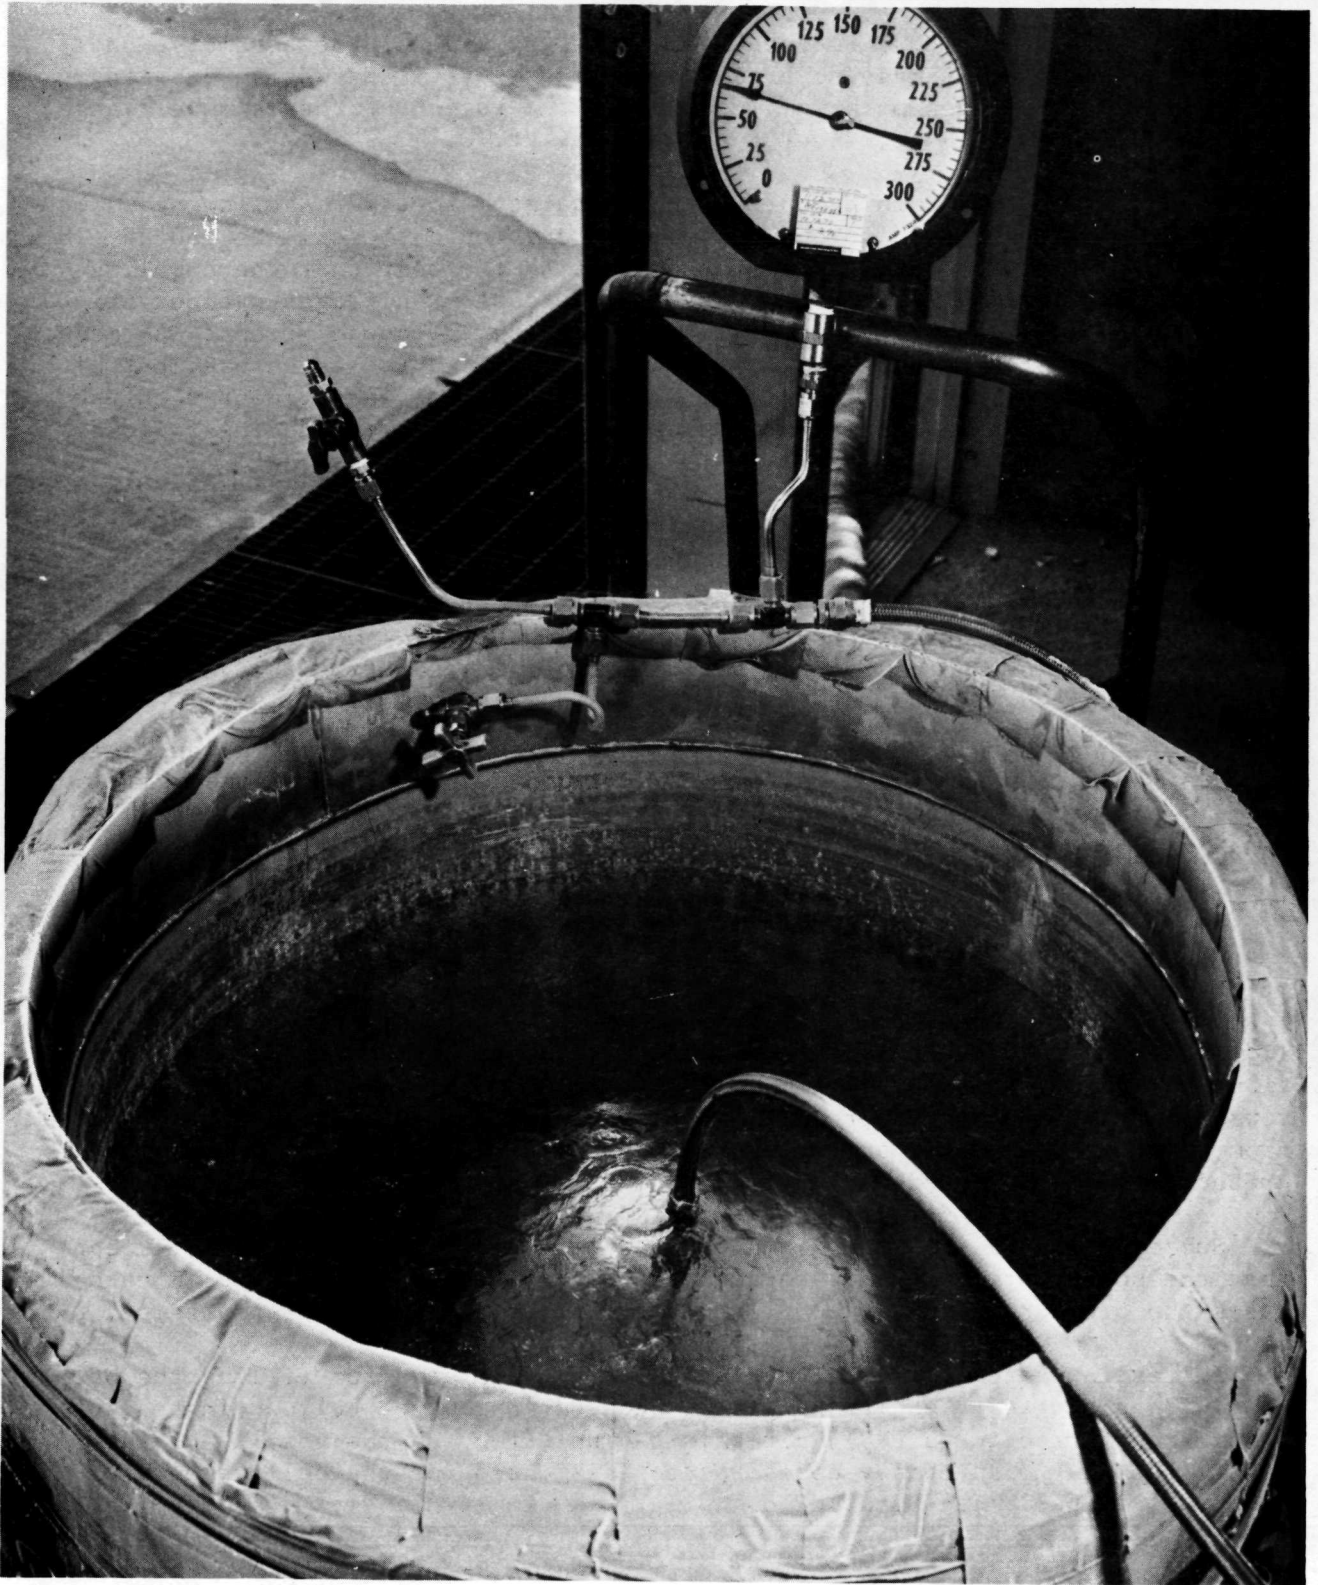
Figure 28 Bellows Assembly 8 Being Chilled during Pressure Test

- 6) The GN_2 source was reconnected to the gas side of the assembly, and an attempt was made to pressurize the assembly. Excessive bubbling of the nitrogen bath was observed in the region of the bellows flange, indicating the presence of a leaky gasket.

The test was then terminated, and the apparatus secured. Following warmup of the assembly, the bolt torque was checked and found to still be 160 in.-lb (18.1 N-m). It was concluded after reevaluating the test that the bubbling was probably the result of heat input from the gaseous nitrogen pressurant rather than leakage through the gasket. Therefore, a second attempt was made to conduct the pressure test following the same procedures as before, but with the bolts torqued to 200 in.-lb (13.8 N-m). No leakage was evident with the application of a slight positive pressure, so the test proceeded as follows:

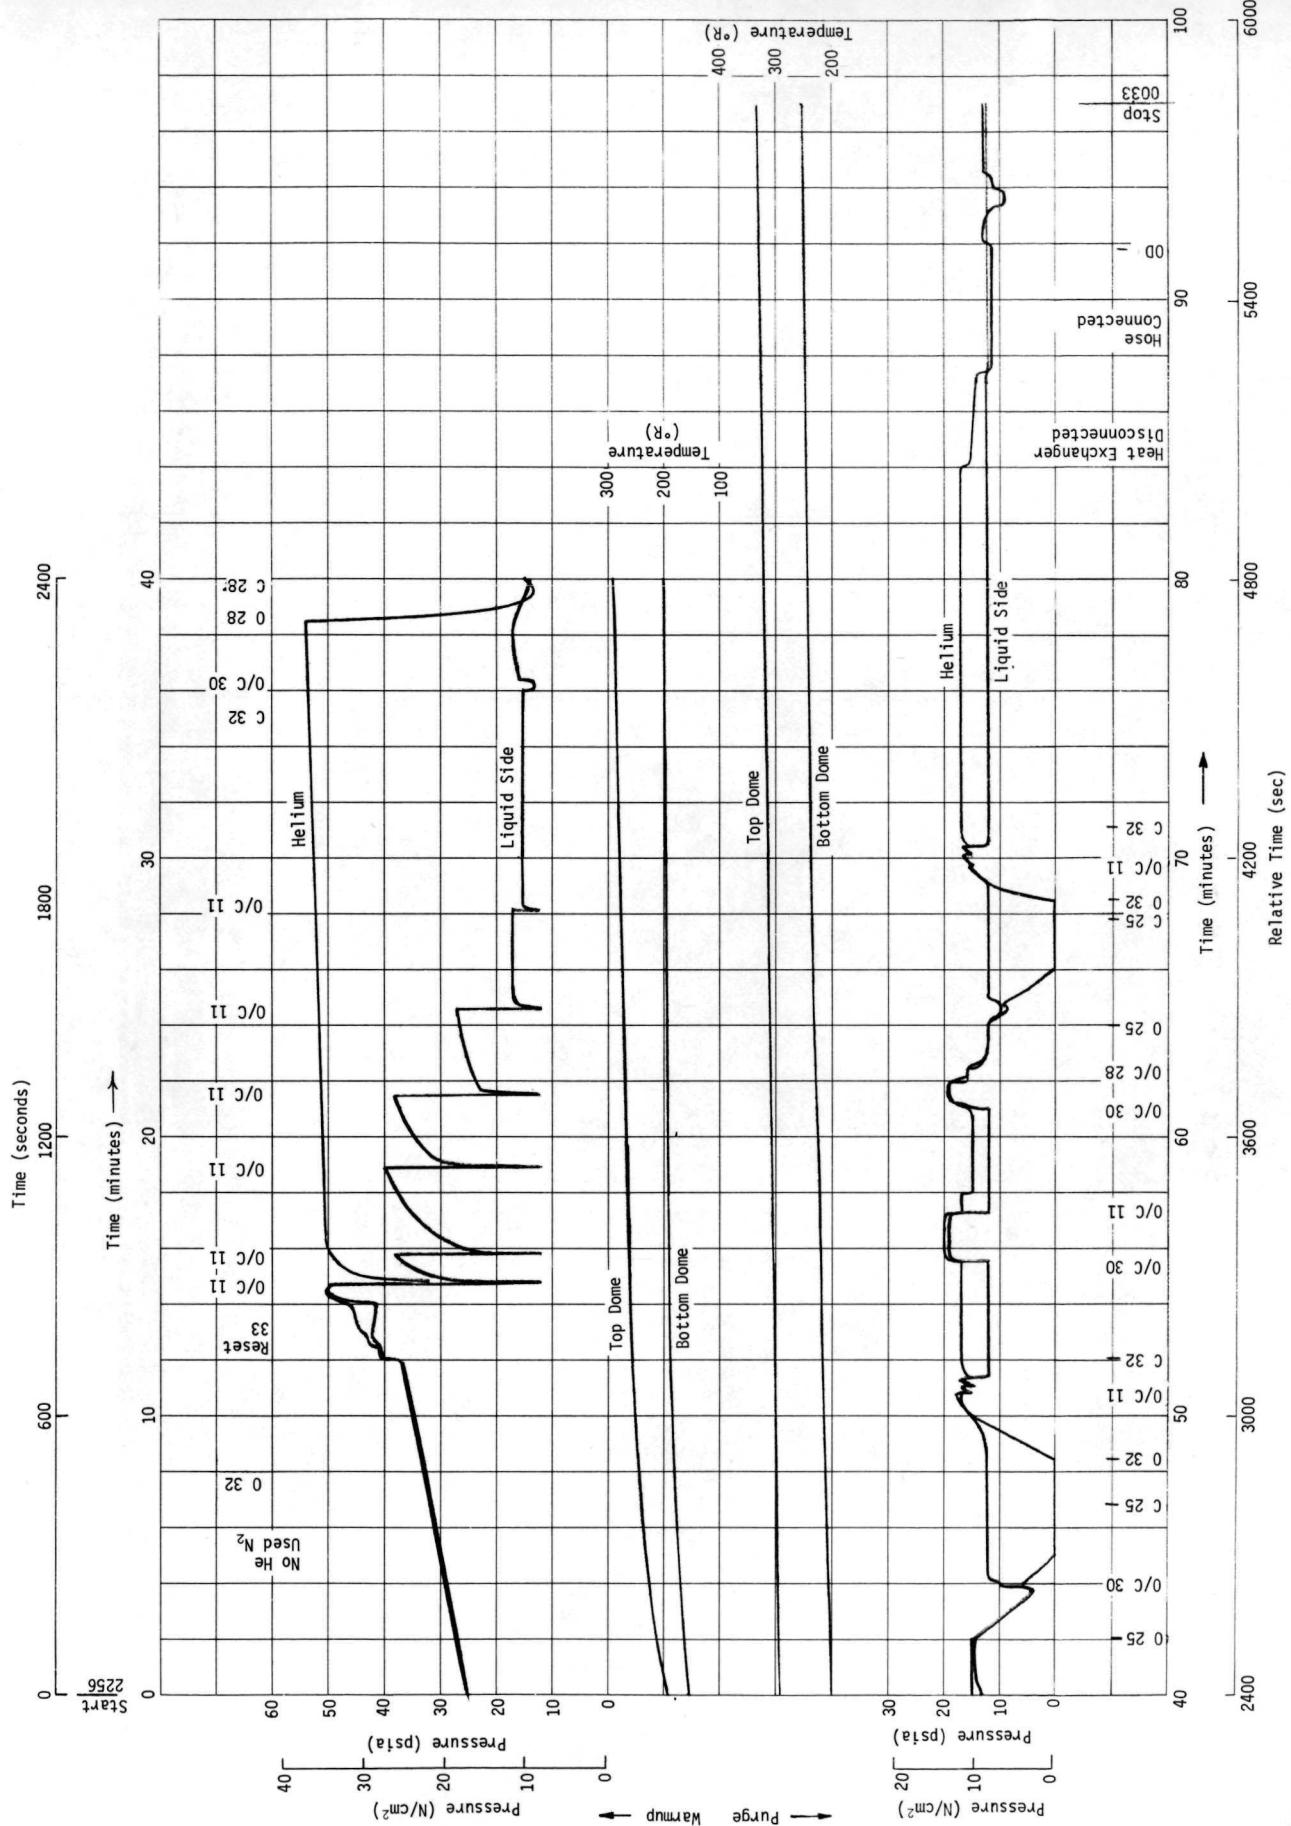
Figure 40 Warmup and Purge Events

The reason for the slow pumpdown of the bellows is not precisely known, but it was probably the result of an inadequate vacuum purge of helium from the bellows. No pressure readings are made; only the exhaust noise of the vacuum pump is used as an indicator of the pressure level being attained. Figure 40 shows that the vacuum pump was operated at 0 psia (0 N/cm²) for less than 4 minutes (240 sec) during the first purge cycle, and only three minutes (180 sec) the second time.

When this series of tests was completed, it was decided to inspect the bellows for evidence of premature failure. The entire expulsion device was removed from the cycle test system, the lines capped to prevent contamination, and the bellows assembly removed from the pressure vessel to permit inspection. It was found that both end convolutions of the bellows were distorted for a distance of ~90 deg (1.57 radians) around the circumference. The convolutions on the flange-end had sustained the most damage (fig. 41); the one at the guide-ring end had "rolled-out" only a small amount. The two regions of distortion are not in the same axial plane. The points of maximum deflection are located approximately 100 deg (1.75 radians) from each other. The exact cause of this distortion was not and is still not known, but it was evident that this condition would have to be corrected before proceeding with the cycle tests.

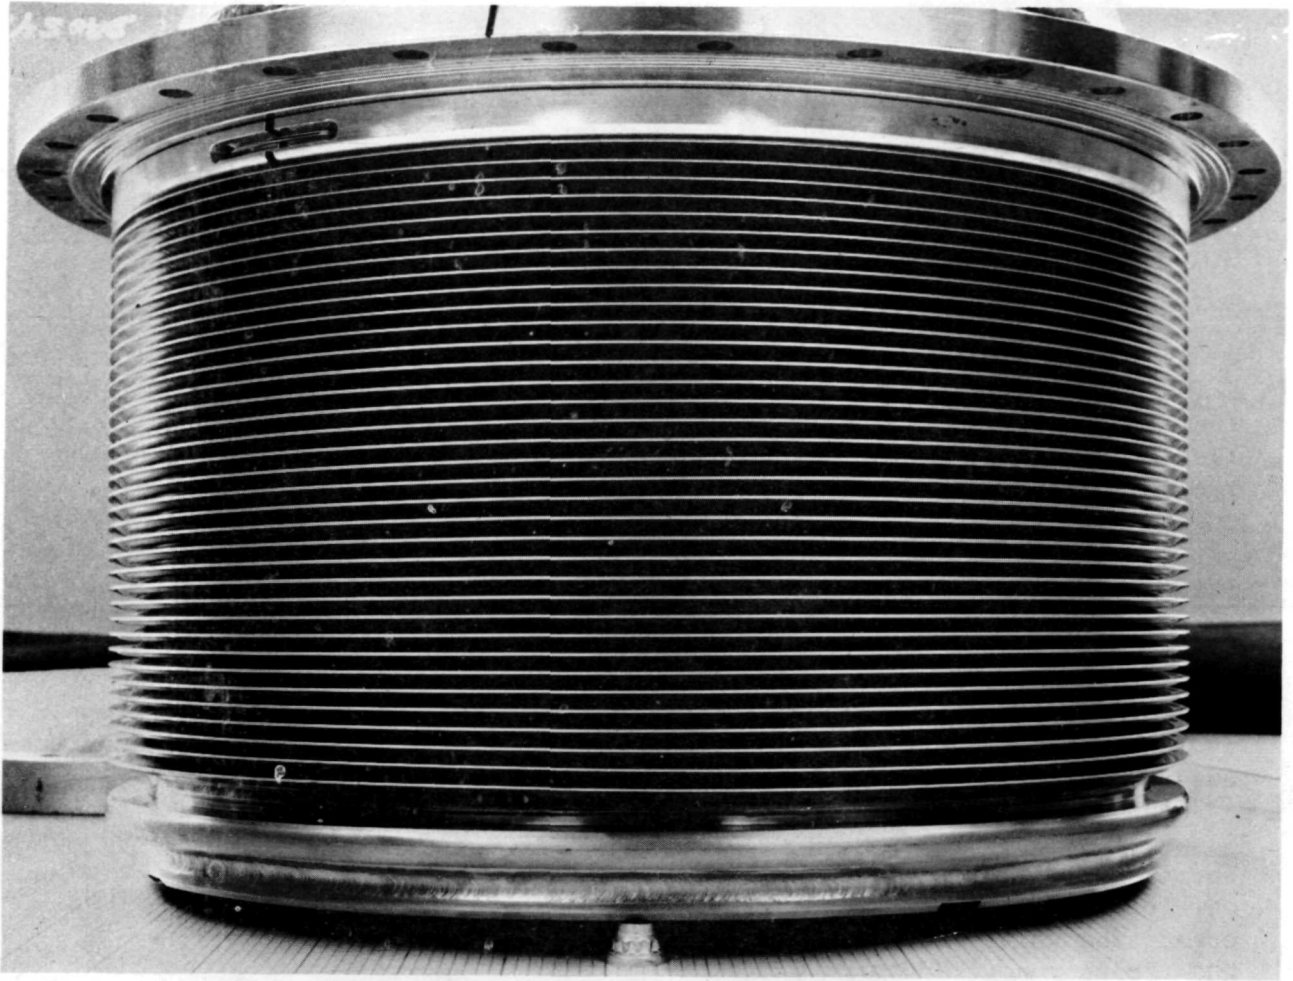
Figure 45 Bellows Assembly 5 After Cycle 74

The bellows assembly was then removed from the test system, the lines capped to prevent contamination, and the bellows assembly disassembled and inspected. No evidence of damage was noted. The convolutions appeared to be in exactly the same condition as they were before the tests (see fig. 45). The convolution at the guide-ring end showed no tendency to "roll-over" even though it had remained unsupported throughout this series of cycle tests.

To permit visual inspection of the bellows, the bolts were removed from the flanged section, and the bellows assembly withdrawn from the pressure vessel. Visual inspection revealed no discrepancies. The bellows looked exactly as it had the last time it was inspected on 26 October 1970 when the first 74 cycles were completed (fig. 45). There was no evidence of progressive distortion of the end convolutions.

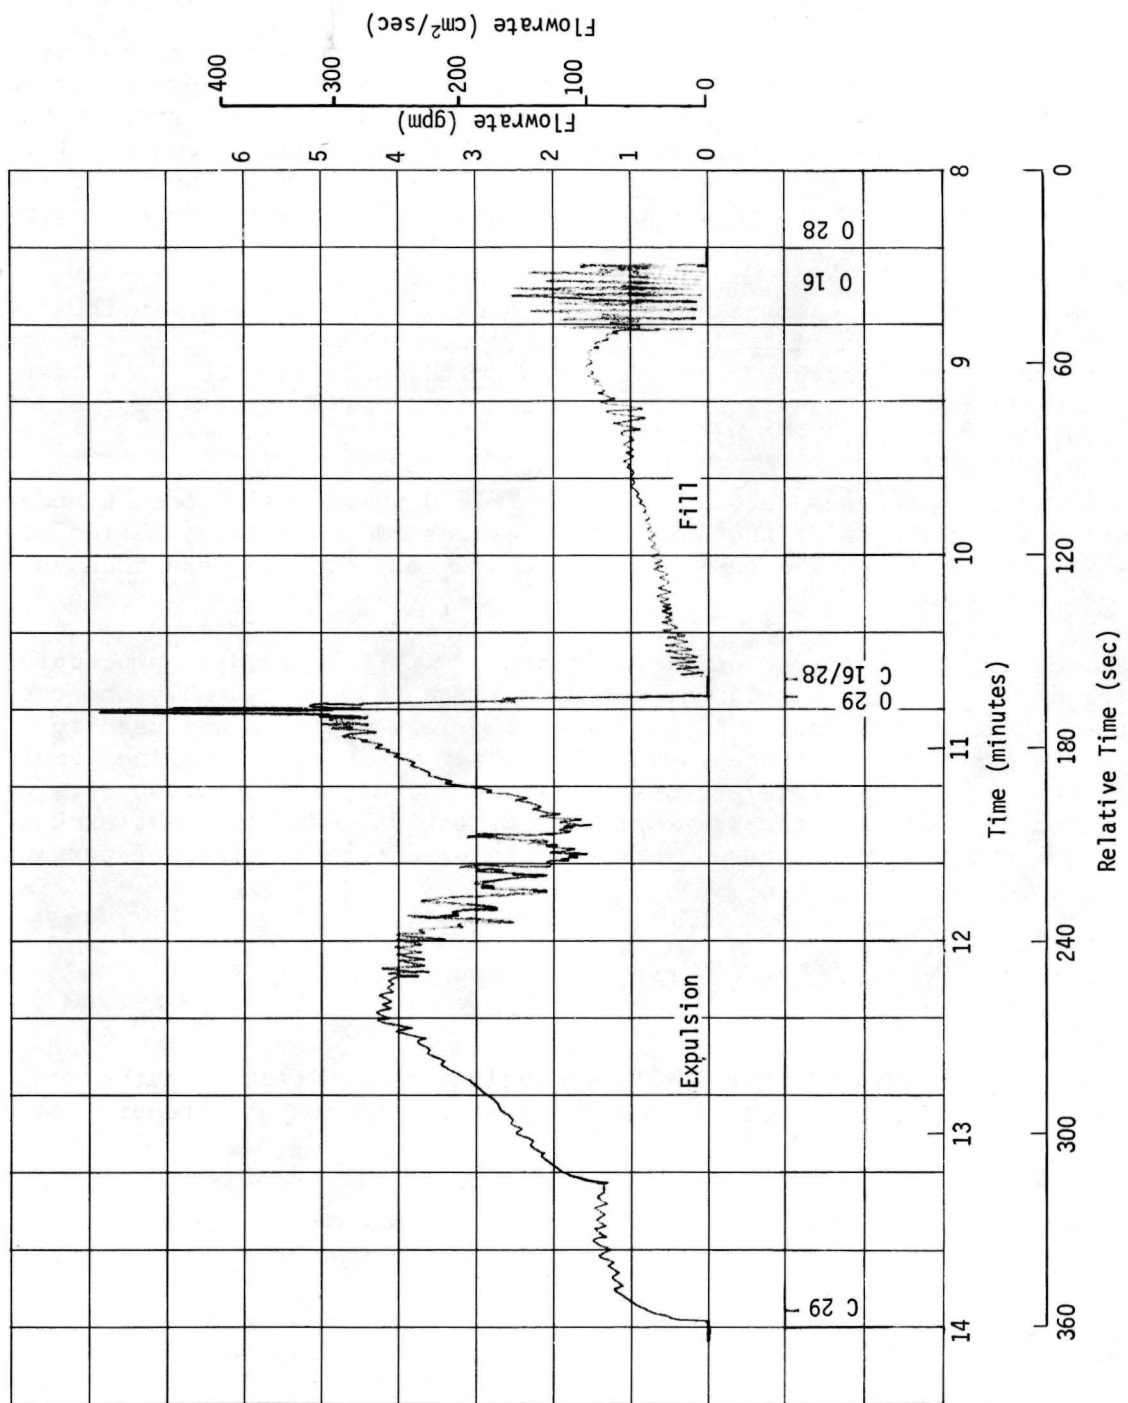
Figure 46 Flowrate Data for Cycle 76 (Inadequate Cooldown)

As usual the first few cycles were poor as evidenced by long fill and expulsion times, and excessive flowmeter oscillations. Actually, the first few cycles accomplish the final cooldown of the system (including bellows), and therefore, involve a considerable amount of two-phase flow. The flowmeter record for cycle 76 (a typical "poor" cycle) is reproduced in fig. 46.

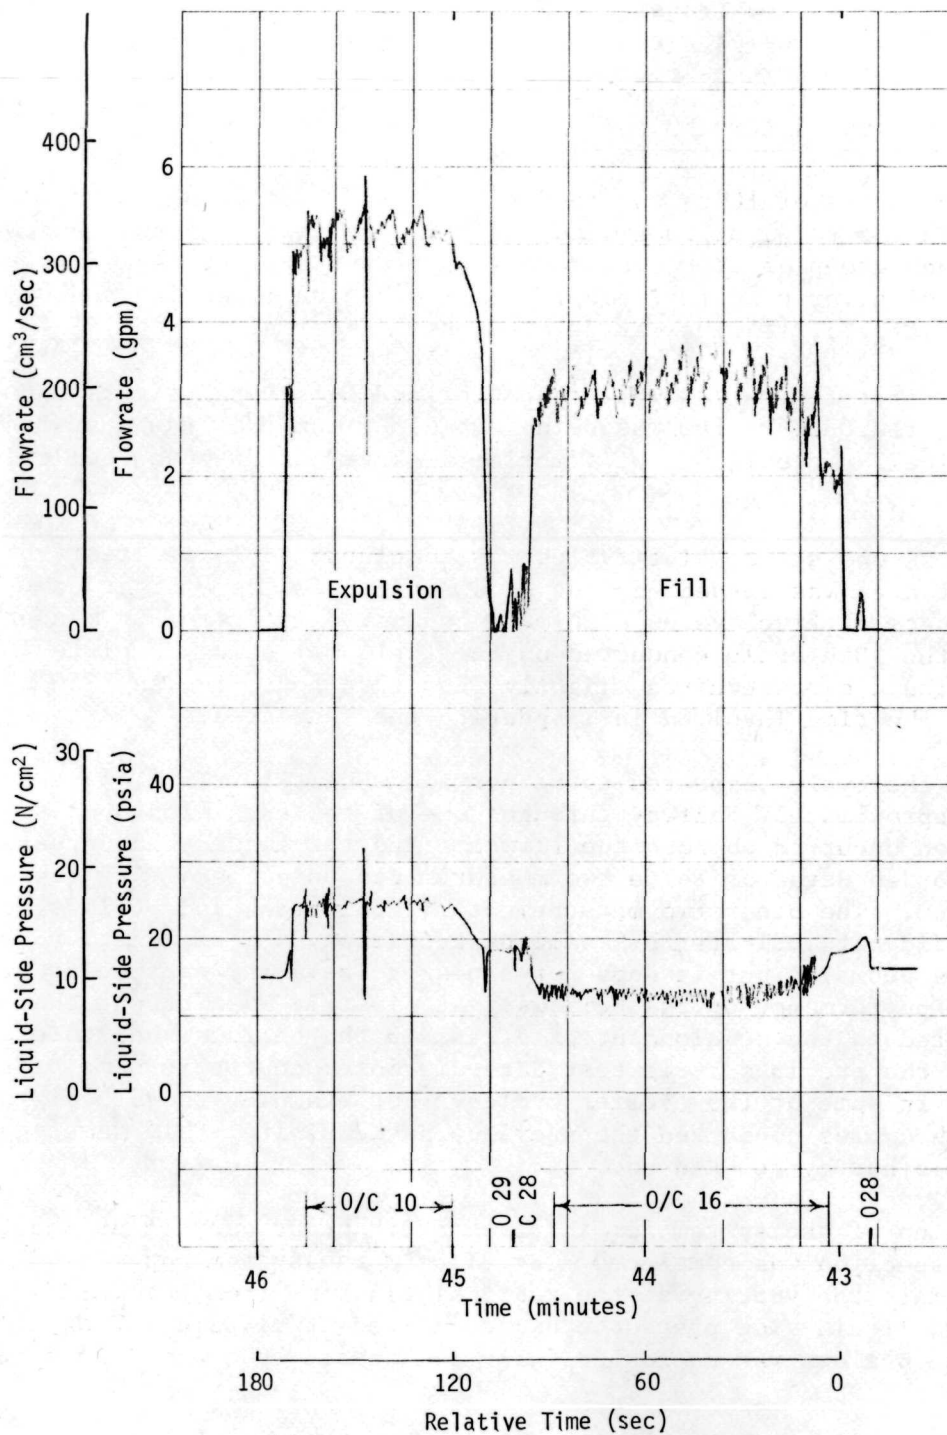
Figure 60 Perturbation during LF_2 Cycle 41 (4/13/71)

All the cycles appeared to be normal, except that a flow perturbation was noted approximately halfway through some of the expulsion cycles. This perturbation occurred on both the flowrate and the liquid-side pressure recorders. The recorded data for these two measurements on cycle 41 are reproduced in figure 60. The other two measurements (supply tank and bellows gas-side pressures) did not indicate this same perturbation. No explanation has been found for this anomaly, but it does not appear to have any particular bearing on the overall performance of the bellows. At first it was thought that this might be related to the development of a leak in the bellows, but careful review of some of the previous cycle test data disclosed that this same perturbation was present in some of the earlier cycles. For example, the 9th, 10th, 11th, 12th, and 13th cycles conducted the previous day exhibited this same characteristic, but the other cycles did not.

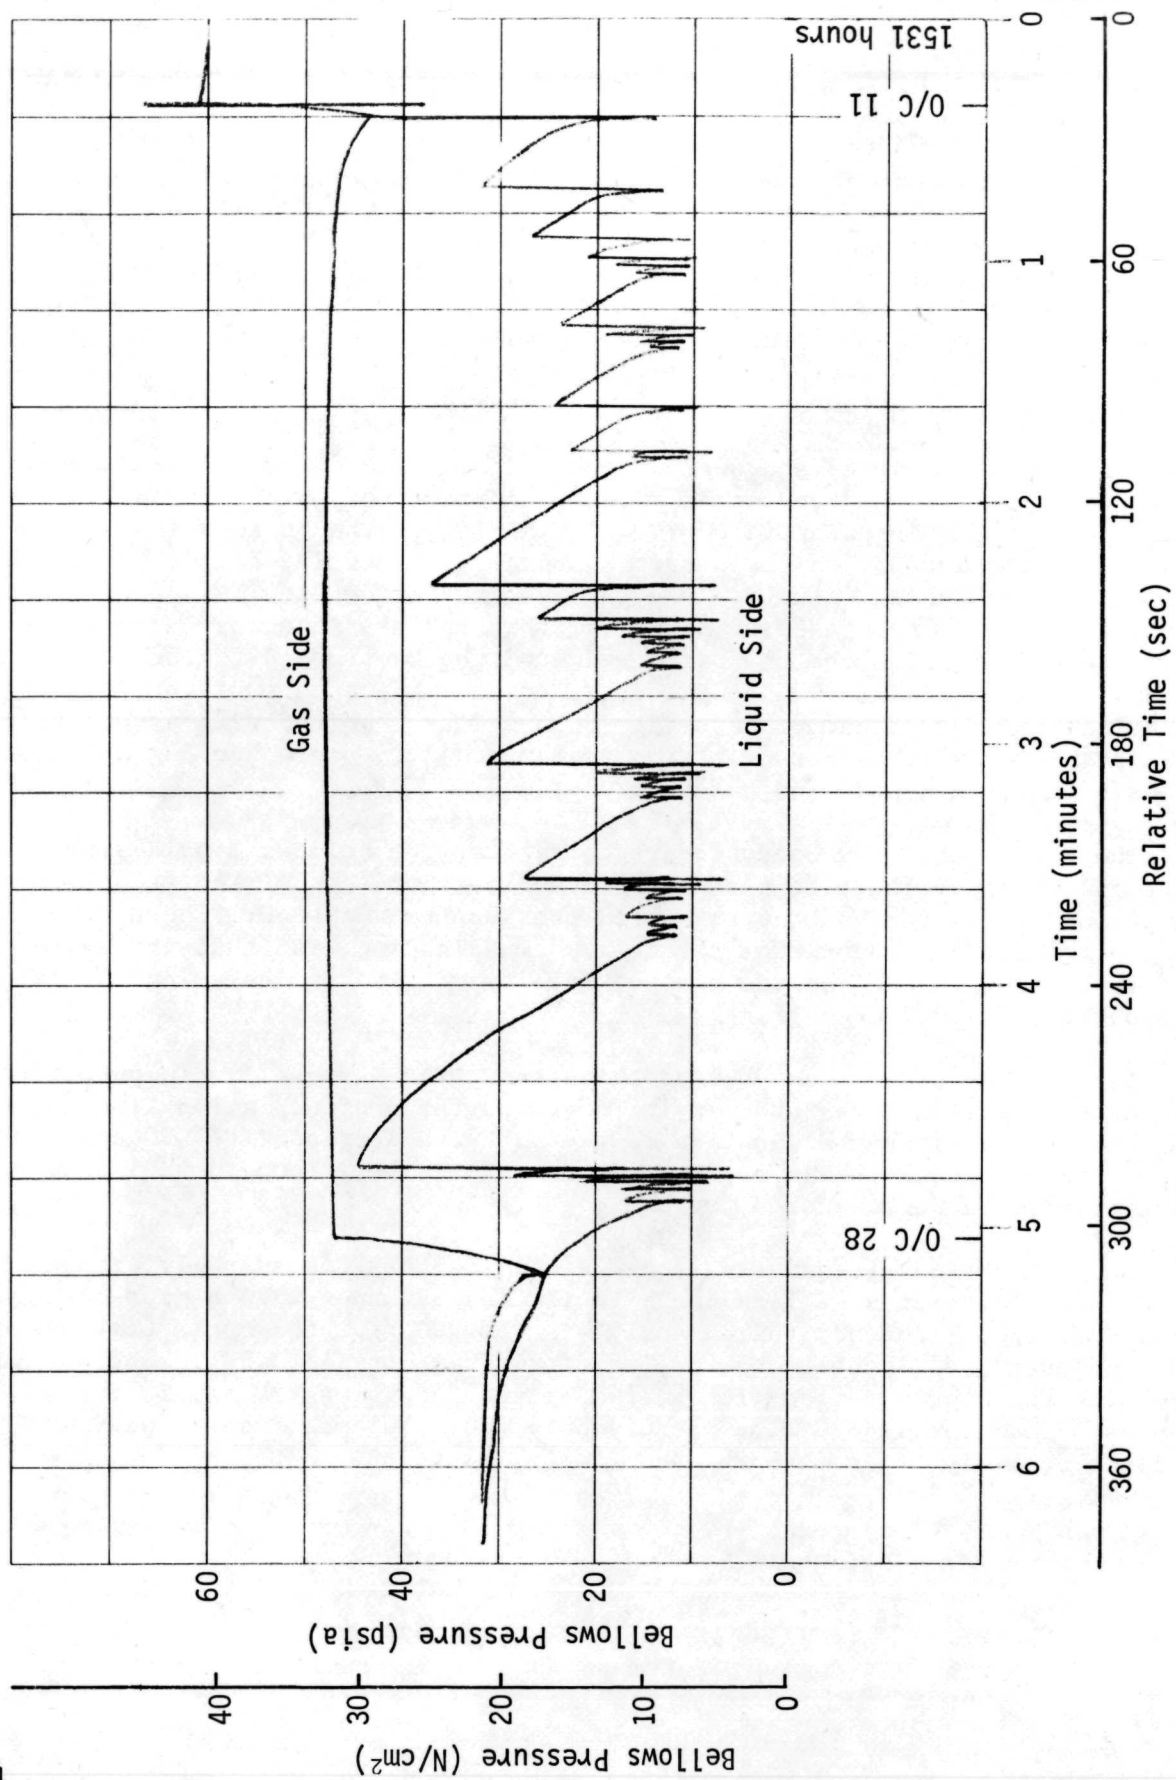
Figure 61 Vent-Down Sequence Following LF₂ Cycle 50 (4/13/71)

The initial cycle of valve 11 seated the bellows, thereby dropping the gas-side pressure to ~47 psia (32 N/cm^2). Continued cycling of valve 11 dropped the pressure to approximately ambient, but each time it rose fairly rapidly to again approach the gas-side pressure. Approximately 40 vent cycles were conducted during a 5-minute (300 sec) period without producing any permanent reduction in pressure. Pressure history during this time interval is reproduced in figure 61. Note that the rate of pressure rise following each vent is ~40 psi/minute ($0.46 \text{ N/cm}^2\text{-sec}$) until the liquid-side pressure approaches the gas-side pressure. This pressure history is significantly different from the normal pressure history during vent down (e.g., fig. 59), and is a definite indication of a leak through the bellows.

Because of the excessively large leak in the bellows assembly, there was no point in attempting a leak check in the usual manner with a mass-spectrometer leak detector. Instead, the assembly was removed from the cycle test system and subjected to a bubble check. Before removal, the liquid side of the bellows was thoroughly purged with helium by cycling valves 30 and 11 for 40 cycles. Then the liquid line was disconnected, the open ends capped, and the bellows assembly taken into the shop for examination.

After removing the flange bolts, the bellows was removed from the pressure vessel and carefully inspected for evidence of distortion or damage. None was evident. Then the bellows was pressurized slightly with GN_2 , and the bubble check conducted. Two leaks were discovered in the longitudinal weld joints. One leak was in the crest of the 20th convolution from the open (guide-ring) end of the bellows; the other was located 180 deg (3.14 radians) from the first one (in the other weld joint) in the crest of the 18th convolution. No immediate attempt was made to determine the size of the leaks, but they were obviously orders of magnitude greater than the 10^{-6} scc He/sec leak rate considered acceptable. It is possible that other very small leaks were also present, but these were not discernible. Therefore, this concluded cycle testing of bellows assembly 8. Further evaluation of the leaks in the bellows is discussed in a following chapter.

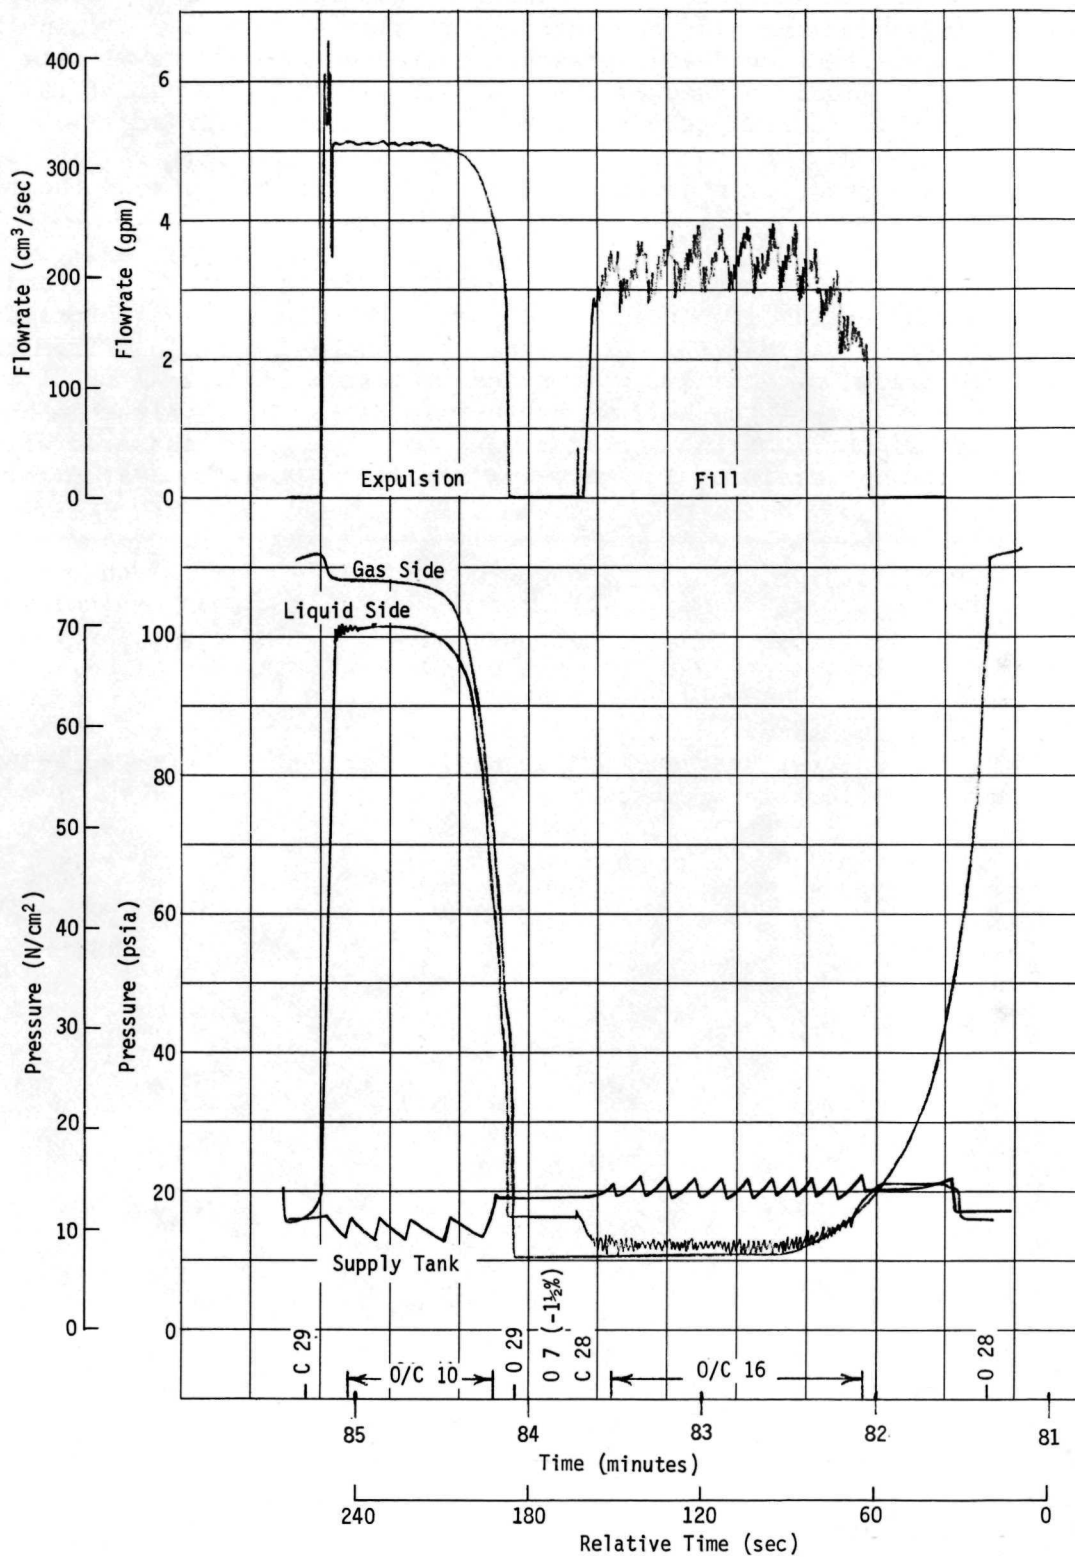
Figure 64 Data for LF_2 Cycle 48 (4/29/71)

The last set of five cycles (bringing the total to 50 for bellows assembly 6) was also completed within 20 minutes (1200 sec). Peak expulsion flowrates ranged from 4.7 to 5.4 gpm (297 to 340 cm³/sec). For the 18th cycle (see fig. 64) the flowrate was 5.1 gpm (322 cm³/sec), and was characterized by a spike at the end of the cycle. It is suspected that this spike is indicative of a leak through the bellows, because it occurred during each of the last cycles (but not the previous ones). The bellows was found to leak badly following this series of cycles.

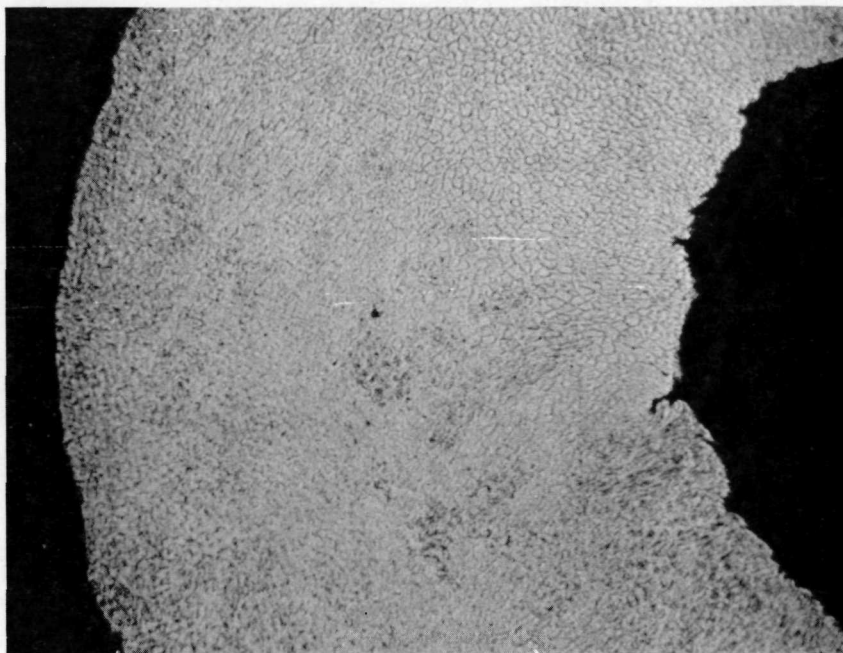
Figure 70 Etched Cross Section (Unused Bellows)

Cross sections of two typical convolutions from the noncycled bellows are shown in Figures 69 and 70 at 250X magnification. One of these shows a polished surface, the other an etched surface. Both show evidence of very small surface cracks (initiators) on the inside surface that apparently were generated during forming of the convolutions. These could be expected to propagate inward from the surface if subjected to large cyclical stresses. No cracks, however, were observed on the exterior surface of the weld joint. Note that the polished specimen reveals the cracks more clearly than the etched surface.

Cross sections of typical convolutions from bellows 5 (cycled in LN_2) are shown in figures 71 and 72 at 200X magnification. Several fairly deep cracks are observed in each convolution, undoubtedly cracks that started from small initiators such as those shown in figures 69 and 70, and propagated part way through the material as a result of repeated cycling.
